## Hughes Warehouse Adaptive Reuse

### Project Overview

Inspired by the history of the Hughes Plumbing Warehouse, this adaptive reuse project transforms an early 20th-century warehouse into an innovative but functional studio space. The renovation preserves the openness and industrial character of the original building, maintaining its expansive 18-ft ceilings and preexisting structural grid. An array of meeting spaces organized within the grid serve as the primary organizational component for the studio, a strategy that has enhanced creative collaboration and communication between staff while also facilitating project reviews, client meetings, design charrettes, and visiting student critiques.

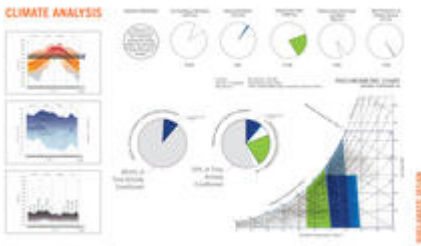
# Bioclimatic Design

Honoring the history of the building, the design team left the existing double wythe brick walls mostly intact but improved thermal insulation through the addition of R20 rigid roof insulation. The roof was upgraded to a reflective TPO cool roof to mitigate heat gain. Though the original steel frames surrounding the clerestory windows would only accept 1/4-inch laminated safety glass, the new punched windows and curtain wall feature one-inch-thick Solar Band 70 XL coated high-performance glass. Steel window box shades surround the windows along the east and west facades. To mitigate solar gain, the new shades are extruded about a foot on the east side of the building, and about two feet on the west. The clerestories and courtyard curtain wall are equipped with translucent, automated shades that control glare without obscuring views and also abide by the astronomical clock. These combined shading strategies have reduced the amount of time that requires active conditioning by 18.5% per year. The courtyard curtain wall illuminates interiors but is shaded by the preexisting south façade, preventing direct glare. A 65 kW photovoltaic rooftop array generates approximately 46% of the energy needed for building operations.

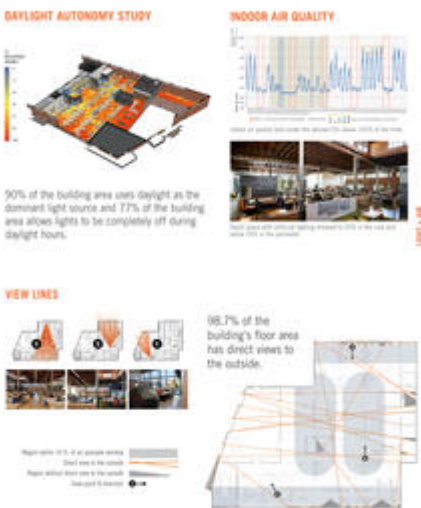
# Light & Air

Other than clerestory windows and several loading dock entries, the building was entirely encased in a double wythe brick wall. While the clerestories provided daylight to the interior, they provided only views to the outside of the sky and did not facilitate the transition from streetscape to interior. By adding punched windows along the east and west facades and a glass curtain wall to the newly inserted courtyard, views to the outside are available in 98.7% of the floor area. Additionally, the clerestories, which had been painted over, were made

operable once again, providing natural ventilation to building occupants when desired. 60% of the office floor area is within 15 feet of an operable window, accessible to 48 of 77 full-time employees. CO2 meters monitor indoor air quality, which fall below the threshold for indoor CO2 levels.

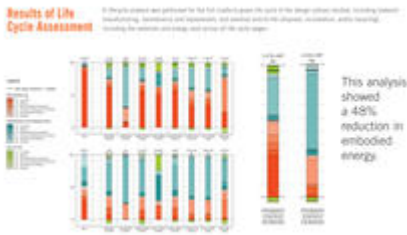
## Materials & Construction

With the attitude that the most sustainable building is the one that is already built, existing elements were cleaned up but remain largely intact. The structure was left exposed to minimize material use, and materials were repurposed wherever possible. Furniture from the previous office was remilled and reassembled to create workstations that supported the open plan. Reclaimed teak was used for doors on meeting pods. Selected in part for their durability, glass and steel components—such as punched windows and a window wall overlooking the courtyard—were integrated into the existing longleaf pine and brick structure, providing natural light and ventilation to interior spaces. Timber salvaged from the roof joists was repurposed as stair treads and for board-formed concrete poured onsite. Sections of otherwise unusable concrete floor became pavers in the alley. Recycling, catering, kitchen, and green cleaning policies have been implemented, as well as a composting program for use in the alley garden.

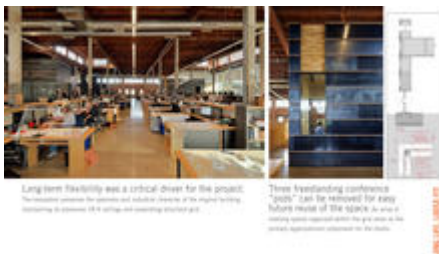
## Long Life, Loose Fit

Because the tenant spaces are occupied under leasing agreements, long-term flexibility was a primary focus. The renovation preserves the building's original open plan structural grid. An array of meeting spaces organized within the grid serve as the primary organizational component for the studio. The enclosed meeting spaces consist of a bank of conference rooms at the rear, built of DIRTT modular wall systems, which can be removed and reconfigured over time. Three freestanding conference "pods" function as meeting spaces, and can also be removed without altering the building's structure. In addition, none of the office furniture is built in except for kitchen cabinets. These strategies allow the space to easily be reused and reconfigured by future tenants.
